Forest Park Safety and Traffic Commission

Year to Date Report 9/26/22

Forest Park Safety & Traffic Commission Report

Eastbound Madison to Northbound Harlem @ Elgin and Crosswalk

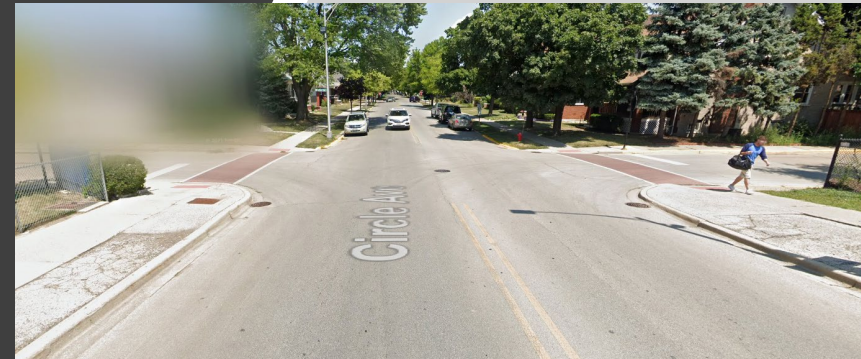
- Circle and Lehmer – No Crosswalk between Dog Park and Veteran's Park
 - Police reports have one pedestrian struck in last year
 - Recommendations:
 - Install crosswalk with proper cutouts on North side of intersection
 - No recommendation regarding timing

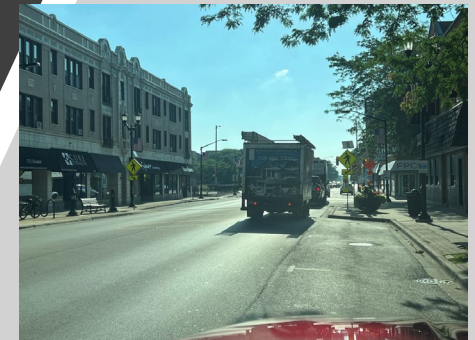
- Madison/Elgin

- See attached report with more details
- Traffic backs up beyond crosswalk at Elgin (East)
- Vehicles attempting to turn NB onto Harlem drive down median
- Creates blind corner for pedestrians and vehicles at the crosswalk
- Recommendations (phased introduction):
 - Option 1: Fix/ensure existing crosswalk lighted signs are functioning
 - Option 2: Physical sign mounted in the street to yield to pedestrians in crosswalk
 - Option 3: Eliminate parking on south side of Madison between Elgin and Harlem to create right turn lane
 - Option 4: Move crosswalk to the west Elgin Ave leg so that it is at the intersection

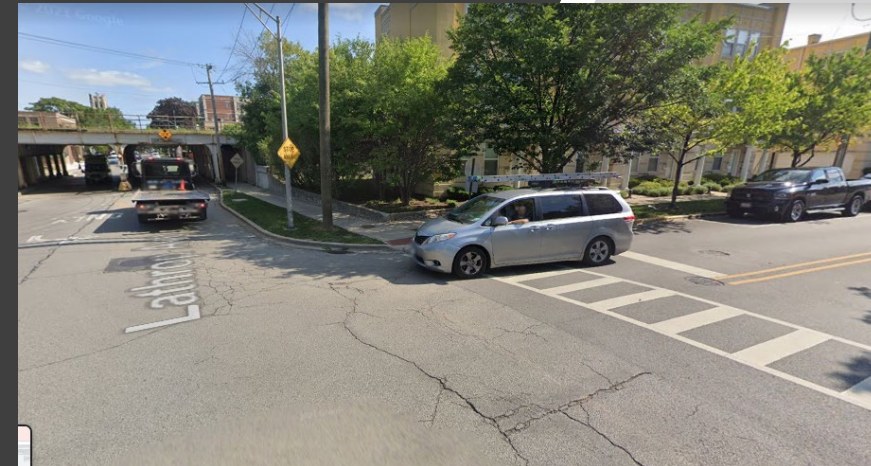
- Lathrop/Brown
 - Pedestrian traffic difficult when NB traffic from Brown blocks intersection or fails to stop
 - Recommendations:
 - Repaint yellow curb in front of Montessori school on Lathrop

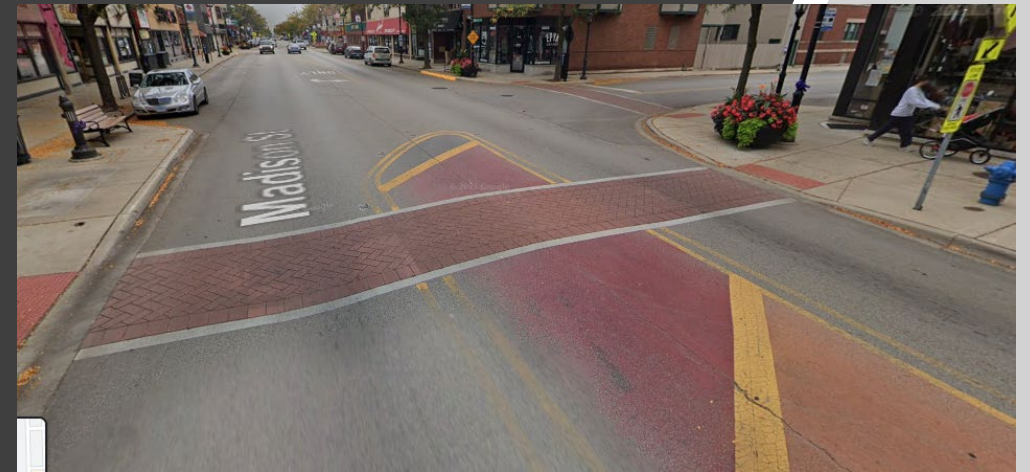
- Madison Crosswalks
 - Commission to continue reviewing
 - Recommendation:
 - Install yield to pedestrian signs at all crosswalks with available medians, just as recommended in the Madison/Elgin report

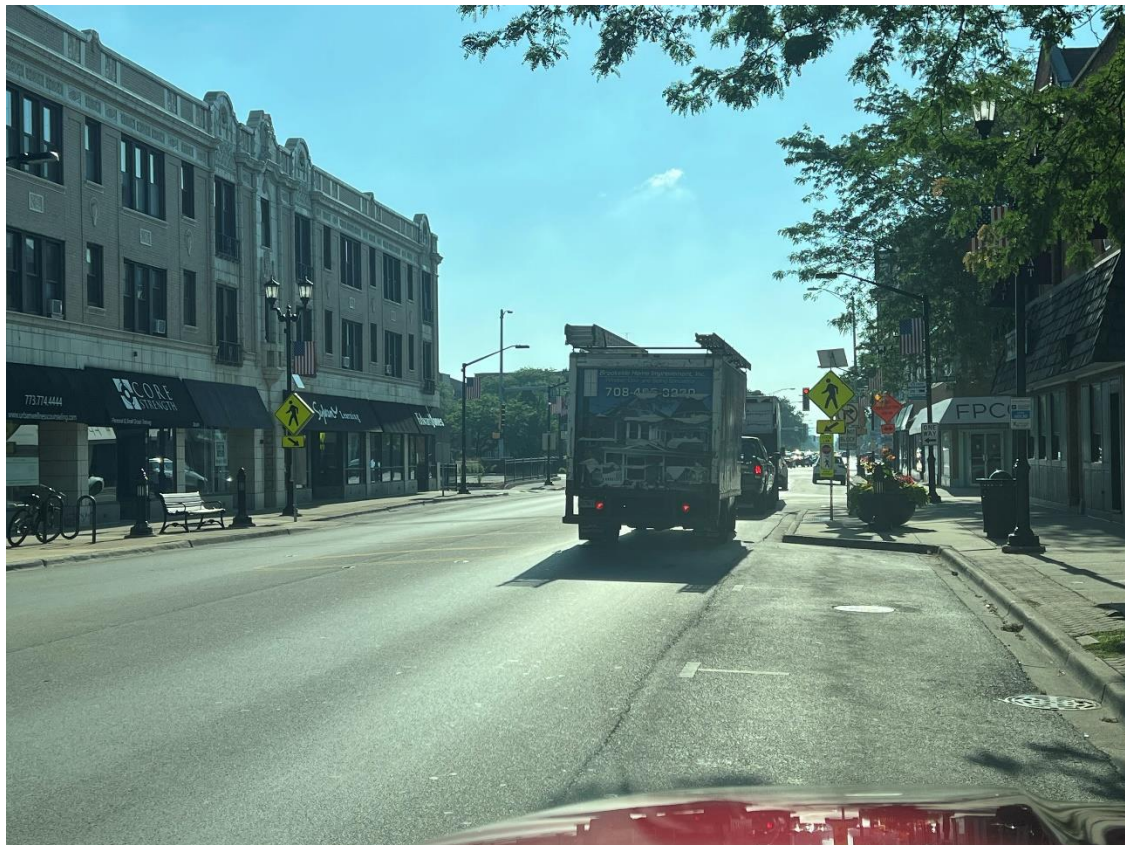
- Problem Statement/Facts
 - There is a mid-block crosswalk located between the two Elgin Ave legs, in front of Fat Duck
 - There is a painted median prior to the crosswalk when traveling eastbound

- There is a left turn lane at Harlem to head northbound
 - Traffic at the light often backs up beyond the beginning of the left turn lane
 - Vehicles will travel down the median when traffic is backed up in order to enter into the left turn lane

- When traffic is backed up pedestrians at the crosswalk are blind to any vehicles driving down the median
 - Emergency vehicles make use of this median during emergencies and require it to be passable

- 10 traffic incidents in that area have been reported from 1/1/21 to 5/23/22 though none were involving pedestrians. Only speaks to documented incidents

- Staff at Fat Duck have reported continual close calls involving pedestrians attempting to cross at the crosswalk
- Proposed Solutions – Ranked in order of preference, propose 1 & 2 for immediate consideration

- Option 1: Fix/ensure existing crosswalk lighted signs are functioning
 - Option 2: Install a break away in-road pedestrian crossing sign as pictured below:

- Datasheet from one vendor attached
- This sign would be mounted in the street, but it would fold over if hit. "Unit has an anti-twist reactive spring assembly that rebounds to upright when struck."
- Sign is removable for plowing and other needs
- We expect that this sign would present not just increased visibility for the crossing, but it would also act as a physical barrier to traffic entering into the median without impeding emergency vehicle traffic.

- Option 3: Eliminate parking on south side of Madison between Elgin and Harlem to create right turn lane
 - This would reduce the line length in the center lane and facilitate legal access to the left turn lane
 - Lane could be right turn only, or right turn and straight. Lanes merge into one on Oak Park side of Harlem.
- Option 4: Move crosswalk to the west Elgin Ave leg so it is at the intersection
 - This is a more expensive option, but would eliminate the mid-block crosswalk and provide greater visibility to it
 - Vehicles would be traversing both the Elgin/Madison intersection illegally, and the remaining median

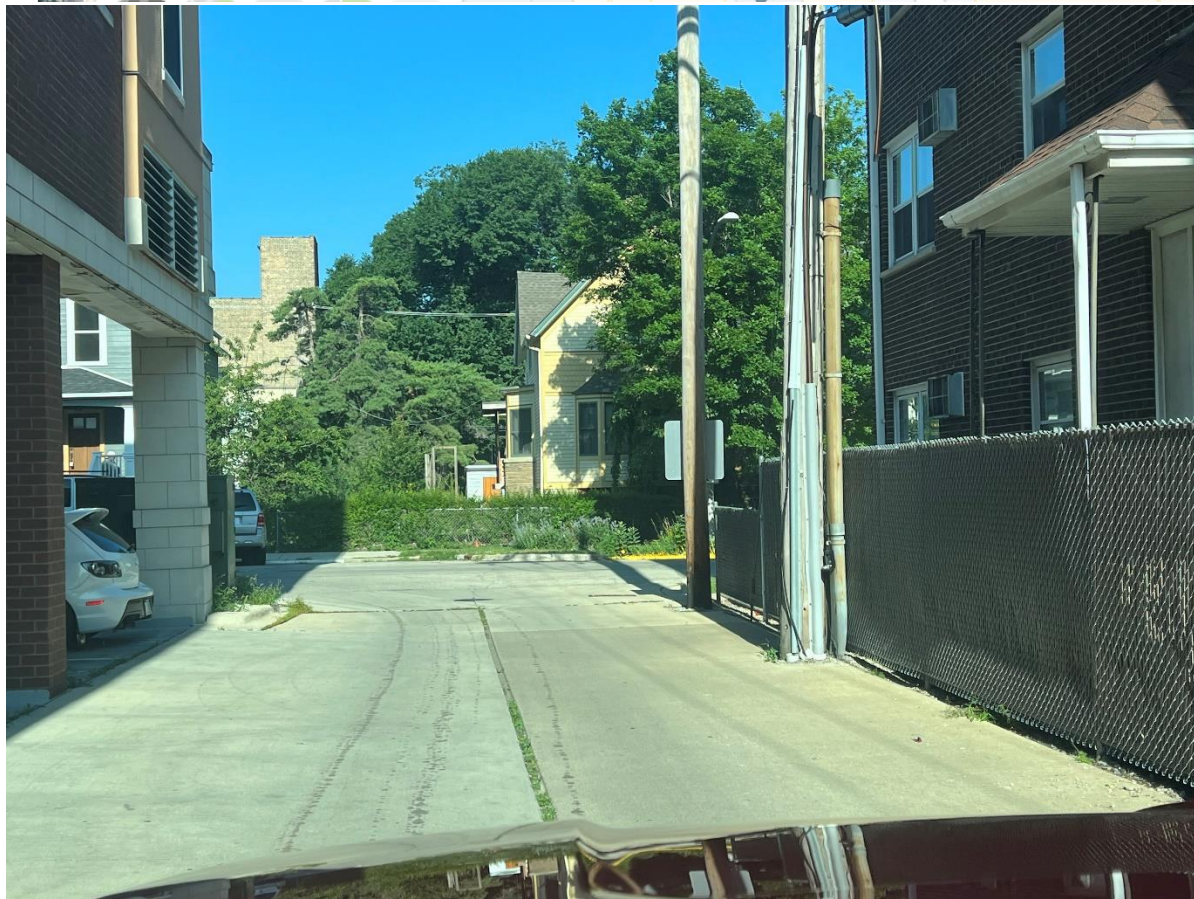
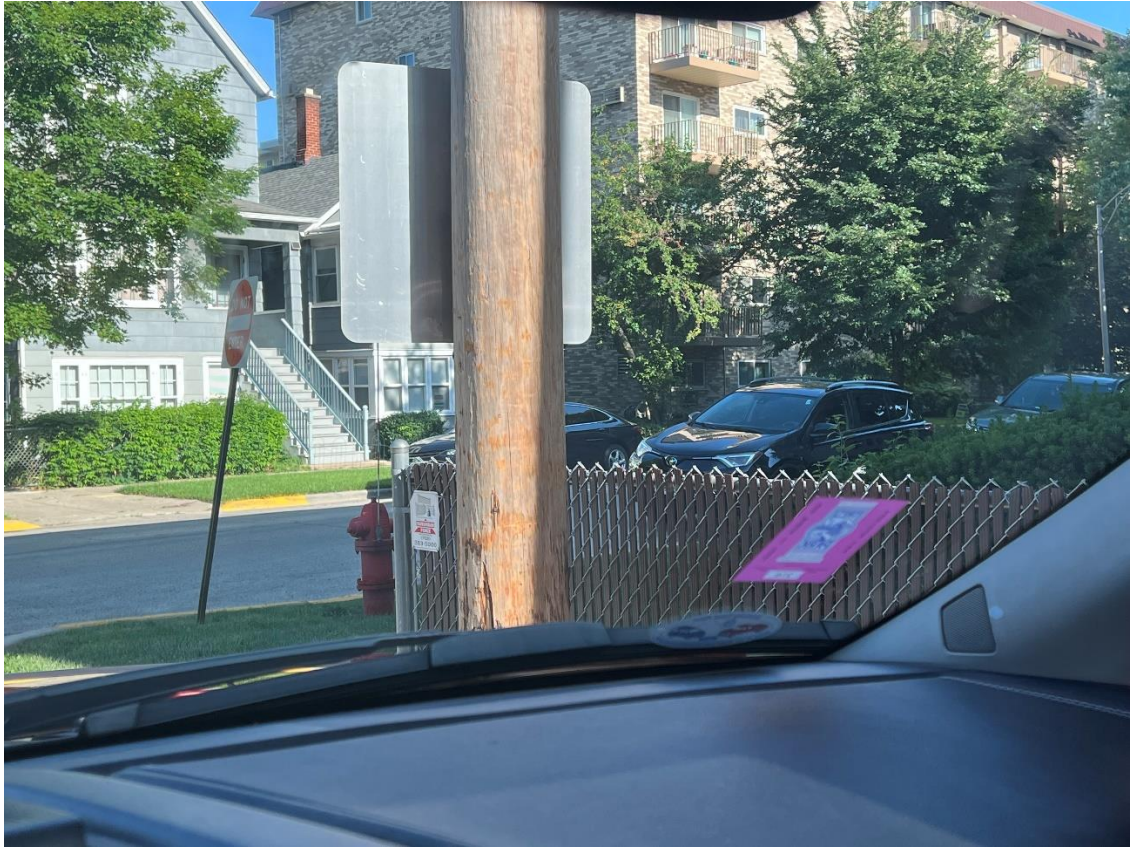
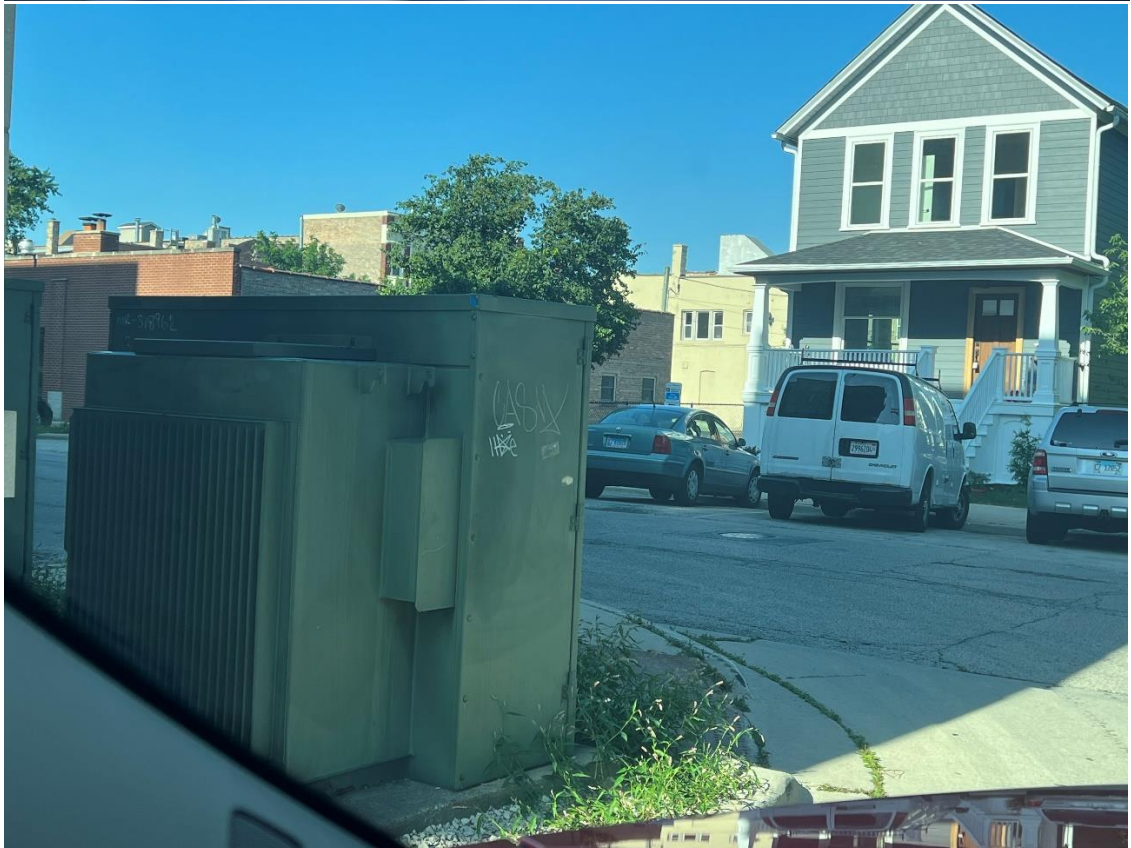
Madison/Marengo/Starbucks Traffic Flow @ Alley and Marengo

- Problem Statement/Facts
 - Traffic exiting Starbucks travels northbound on Elgin or enters the alley north of Starbucks and loops to Marengo to return to Madison
 - There is covered parking in the building with access via the alley as well as a lot north of the alley
 - The westbound exit from the alley to Marengo is blind in both directions to southbound traffic and bi-directional pedestrian traffic
- Proposed Solution
 - Install signs warning of the blind alley exit
 - Install mirrors on both corners
